Progress Report
on
An Evaluation of Complete Dentures
Lined With Resilient Silicone Rubber

311.05-11-3110560

December 31, 1965

Progress Report on An Evaluation of Complete Dentures Lined With Resilient Silicone Rubber

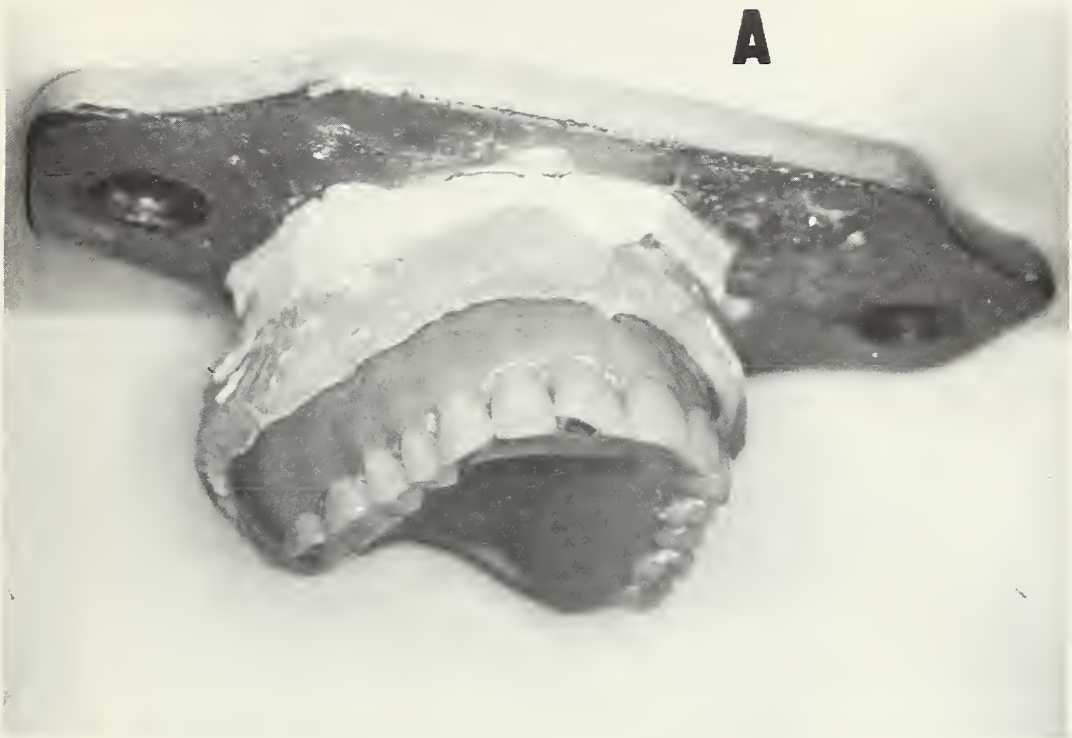
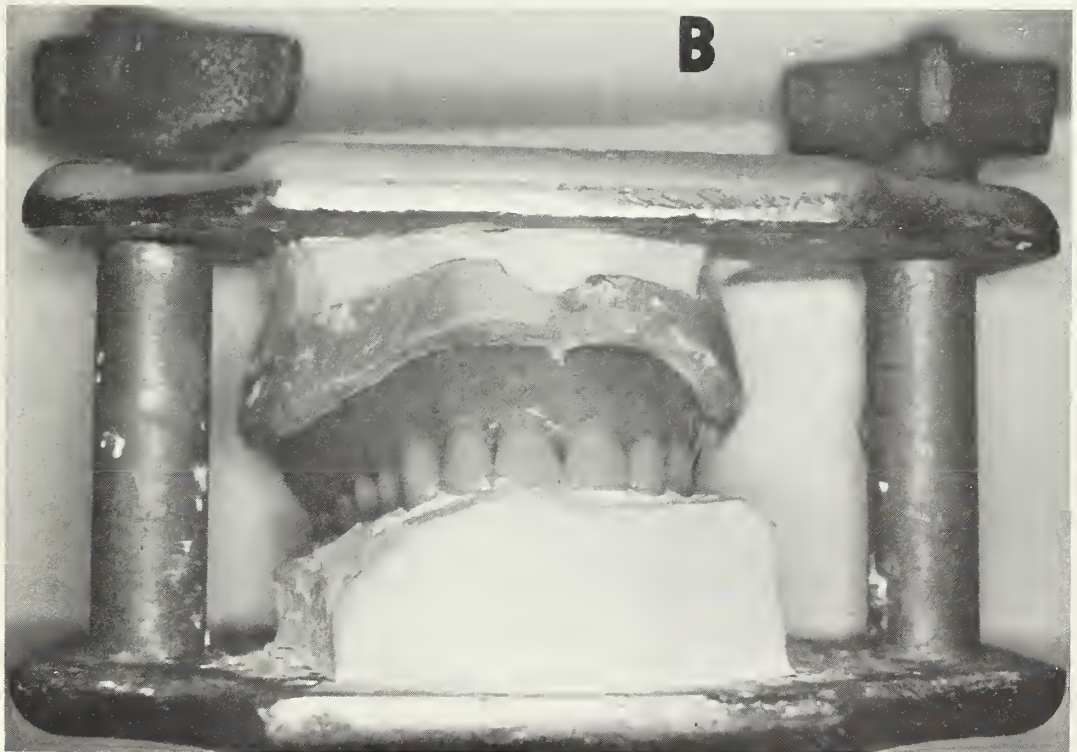
Figure 2. (A) Photograph of an upper denture with zinc oxide-eugenol paste impression wash into which a artificial stone cast has been poured and then the whole assembly attached to the upper member of a duplicating jig. (B) The assembled jig with the plaster of paris occlusal-incisal index on the lower member.

Laboratory procedure*: A dental stone cast was poured into each denture. Then it was mounted on the upper member of a duplicating jig (Figure 2A). An occlusal and incisal index was then made on the lower member of the assembled jig. By so mounting each denture, the occlusal and vertical jaw relations were easily maintained throughout the subsequent procedures (Figure 2B).
